SERVICE BULLETIN**N° 169-148****EMERGENCY ALERT****DATE:** May 29, 2019**REV. :** B - February 4, 2020

TITLE**ATA 64 - TAIL ROTOR FLIGHT CONTROL IMPROVED PERIODICAL INSPECTION****REVISION LOG**

This Service Bulletin is issued in order to require the periodical inspection of the slippage marking of the back-end castellated nut of the TR servo-actuator and the periodical detailed inspection of the TR duplex bearing.

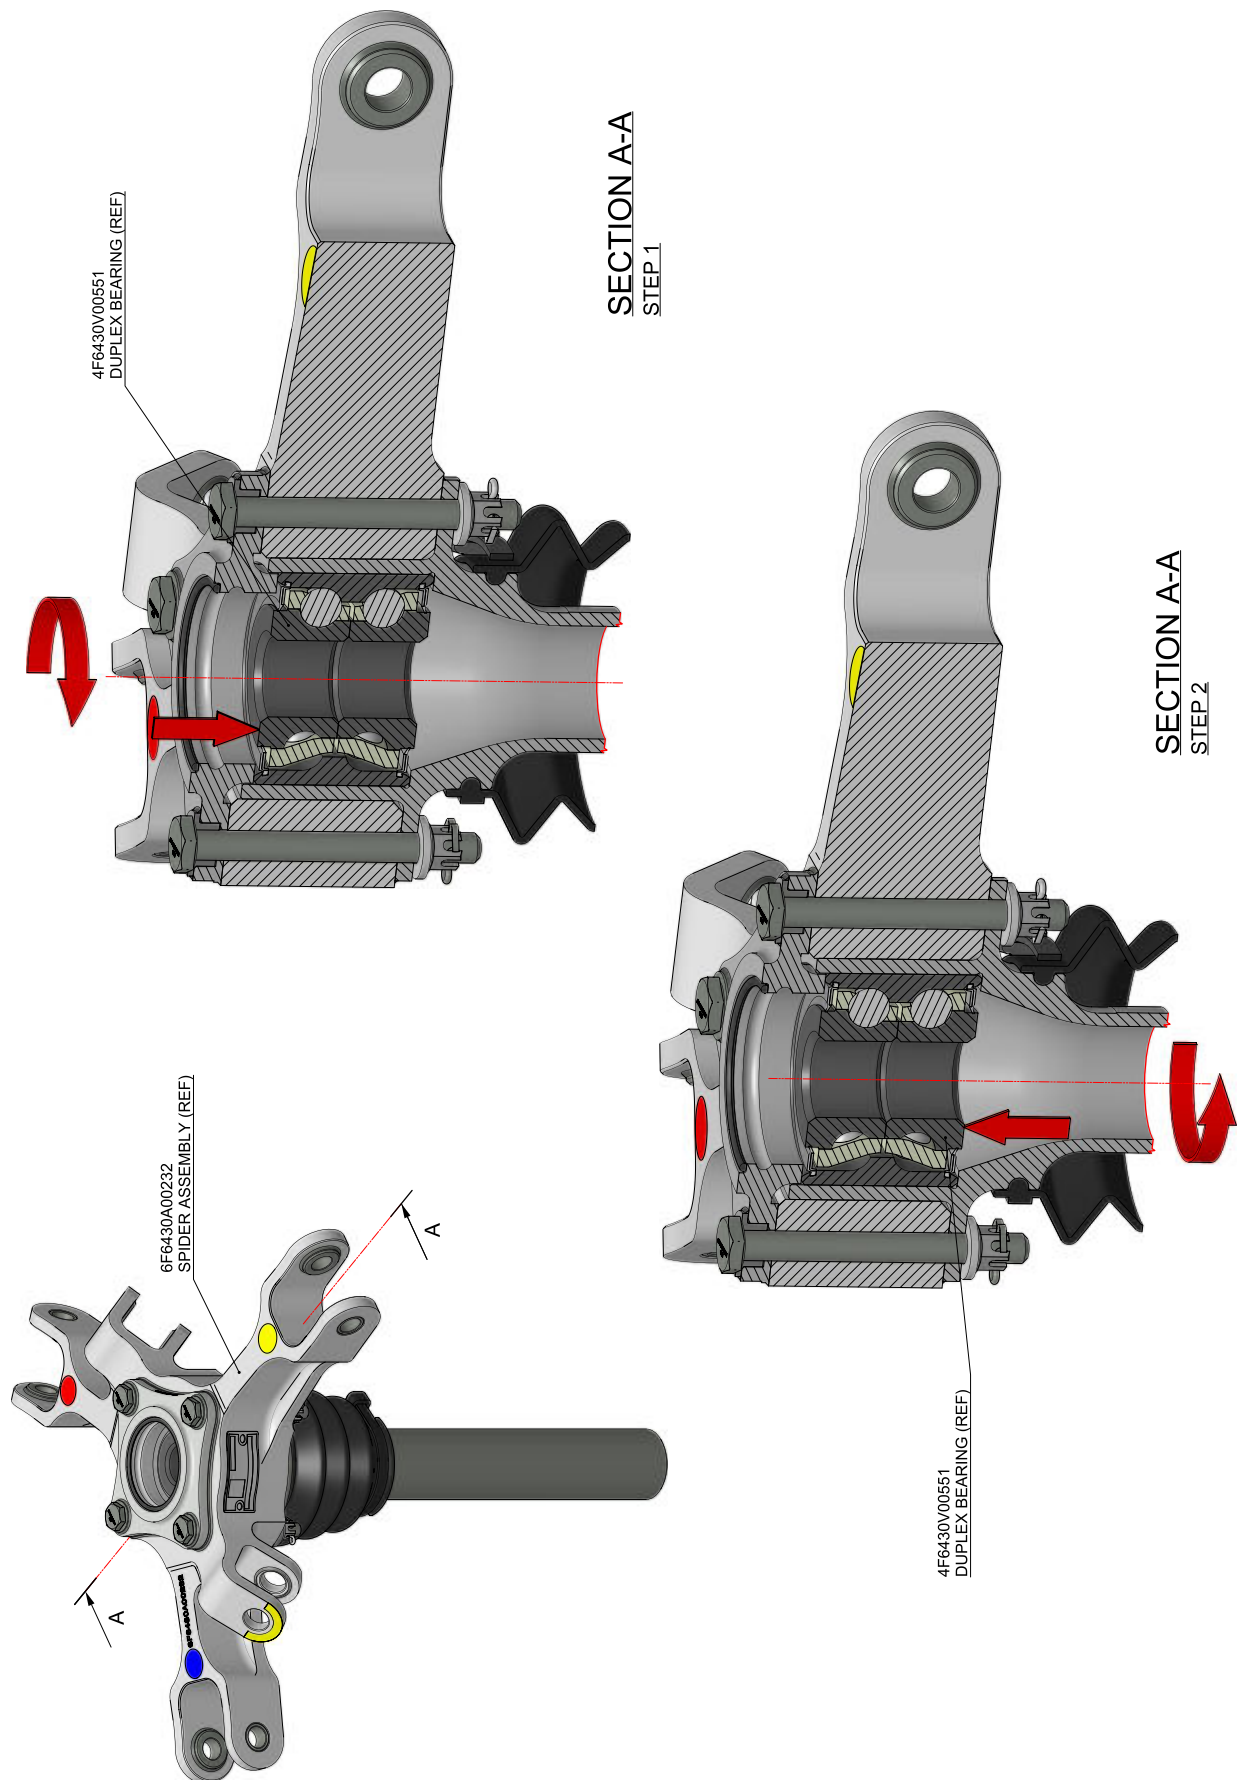
- 5.2 With reference to Figure 6 section A-A Step 1, push the top inner race down and at the same time turn it to feel if there is roughness.
- 5.3 Put your finger into the duplex bearing until you can pull up the lower face of the inner race.

- 5.4 With reference to Figure 6 section A-A Step 2, pull the bottom inner race in the up direction and at the same time turn it to feel if there is roughness.
- 5.5 Repeat the Step 5.1 thru Step 5.4 at least one time to confirm the results.
- 5.6 Record the results of the previous steps on Table V (refer to Figure 11).
